Five-Year Review Report

Third Five-Year Review Report for American Crossarm and Conduit Superfund Site Chehalis, Washington

September 2009

**United States Army Corps of Engineers, Seattle District
And
U.S. EPA Region 10**

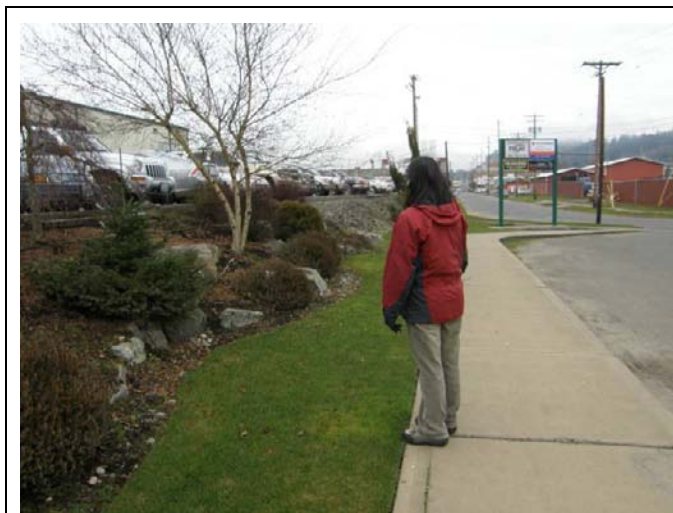
- The areas of the former facility are now developed with two buildings, associated parking lots, and a storm drainage basin.
- Elevation of the development is higher than adjacent street due to the placement of additional material on top of the cap placed during the 1996 remedial action.
- The landfill is currently intact and undeveloped. Debris from the 2007 flood event was observed on top of the landfill.
- The surface water adjacent to the landfill appeared to be have been widened. A sheen was observed on the surface water on the southwest side of the landfill adjacent to the railroad tracks.
- No fencing was observed surrounding the former facility.
- The stormwater lagoon to the west of the former facility is still intact and directly discharges into Dillenbaugh Creek.
- Monitoring wells could not be located due to the heavy vegetation.

Elevation difference between Chehalis Ave and development

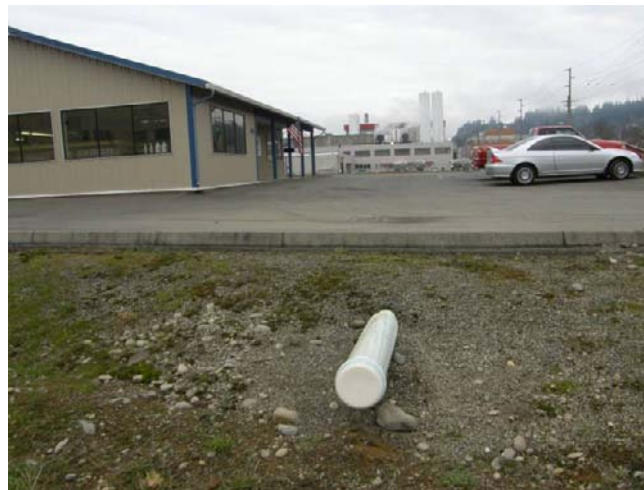
Mystery capped pipe from north development

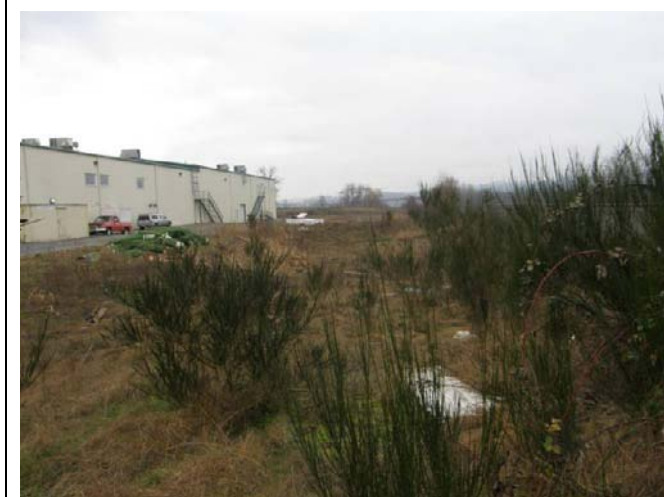
Depression north of stormwater basin facing south

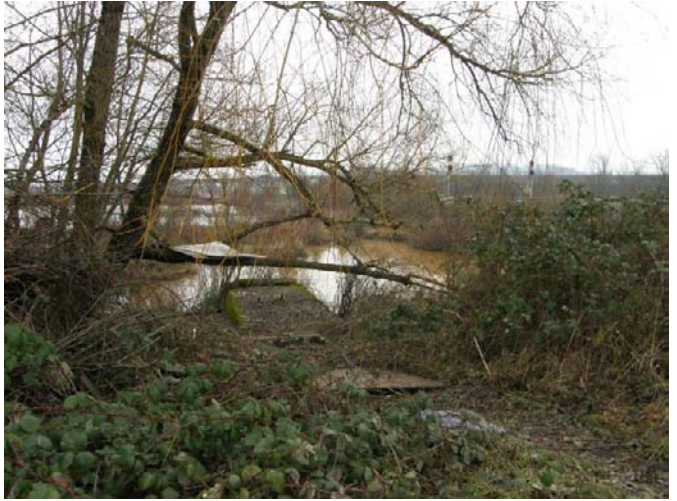
<p>Wetland south of landfill</p>	<p>Concrete slab remaining south of landfill</p>

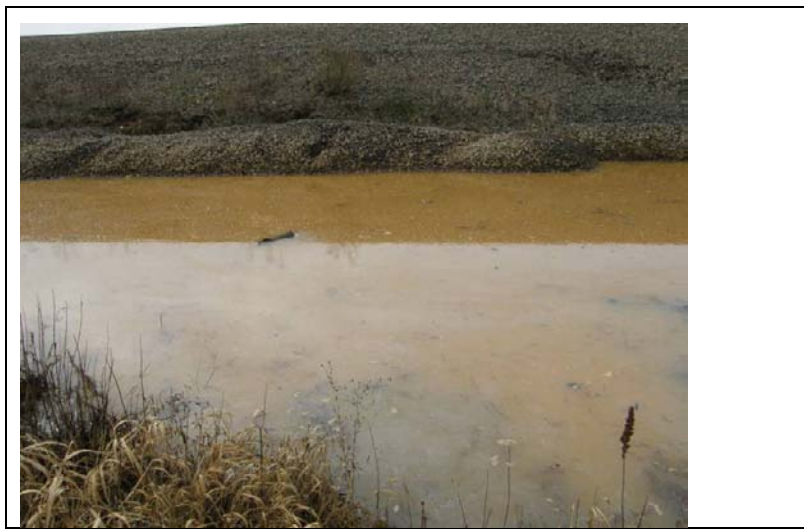
Several prospective sources for PAHs exist near these surface water sample locations including the railroad tracks adjacent to the sampling locations, runoff from the northern portion of the Site, residual surface soil contamination in the wetland area, or perched leachate from the landfill. If ponded surface water samples are collected in the future, it is recommended that off-Site samples adjacent to the railroad ditch and background samples be collected for comparison.

<p>Sheen observed in surface water between landfill and rail line</p>	<p>Western edge of landfill facing north</p>

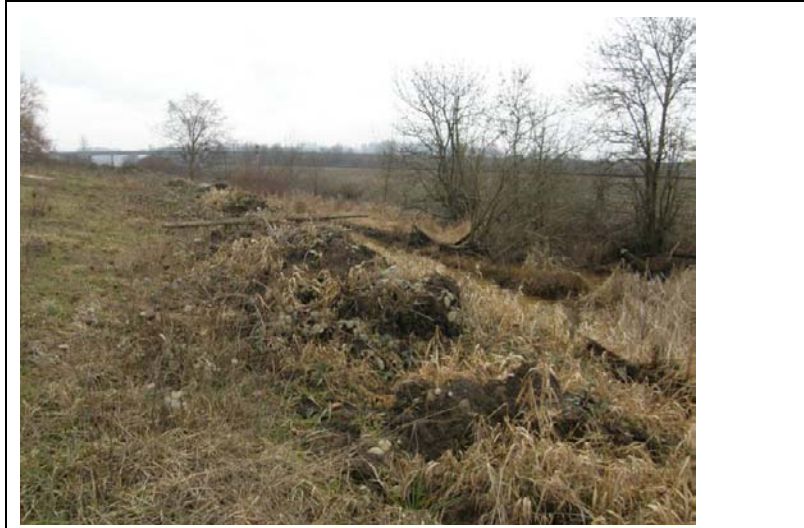
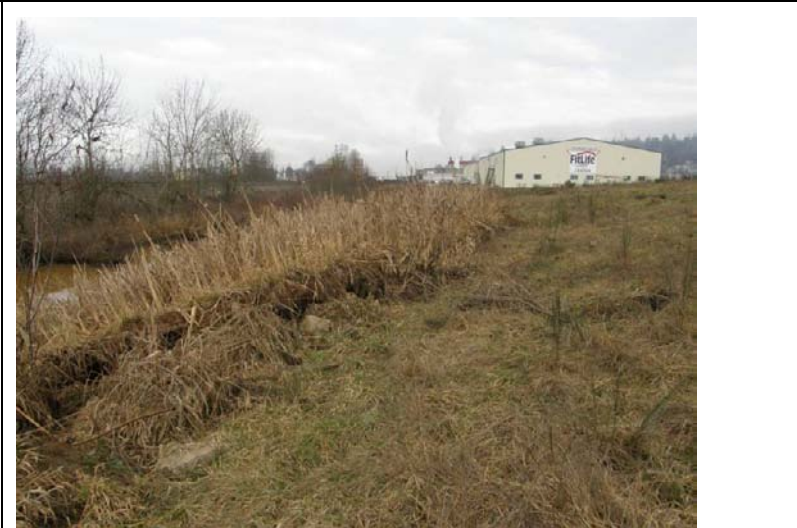
<p>Earthen piles on western edge of landfill</p>	<p>Cattail piles on western edge of landfill</p>

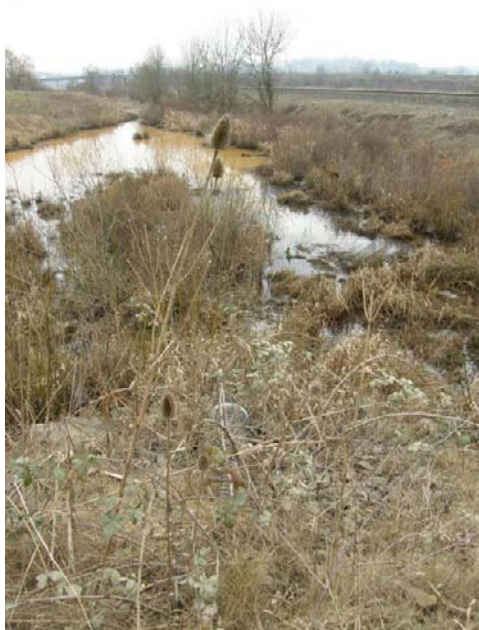
Overflow pipe from stormwater basin to surface water

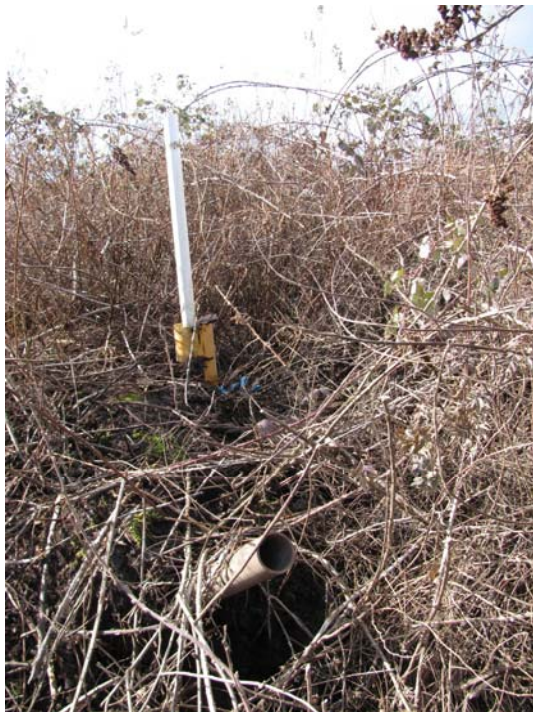
Monitoring Well MW-25

A monitoring well reconnaissance was conducted on March 3, 2009. The reconnaissance team included Sharon Gelinas, from the USACE Five-Year Review team, and Pam Marti, Hydrogeologist, from Ecology. Both of the remaining wells, MW-25 and MW-26, were located. MW-25 was observed to have experienced uplift, resulting in damage, and should be appropriately

decommissioned. MW-26 was observed to have some ground subsidence beneath the protective concrete slab, but still appears to be in satisfactory condition. Photos of the wells are presented in Attachment 2.

- Groundwater monitoring well MW-25 is damaged and cannot be sampled.
- Groundwater monitoring has not taken place since 2001.
- The current Site conditions have changed considerably since the remedial action. Additional fill, buildings and pavement currently cover most of the northern portion of the Site.
- Low-level PAHs have been present in ponded surface water adjacent to landfill.
